**Flood Control Project Maintenance  
Levee Inspections**

**Maintenance Issue Types Only, Levee Inspection Report By Mile - Spring 2020**

**Sutter Maintenance Yard Maintenance Area 0017**

Waterway	Bank	Unit Miles	Inspection Start/End	Inspector
Unit No. 01 Lake County Sutter Maintenance Yard - Middle Creek	Left	3.87	03/04/2020 03/04/2020	Luz Dial

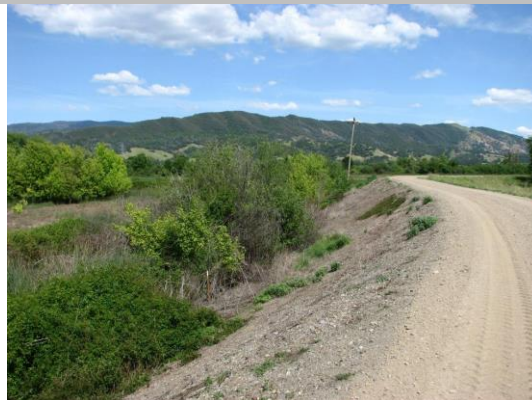
Photo 1 of 1 : SP\_2020\_MA0017\_339\_16\_20200302\_00003.jpg

LM Start	3.41	Rating **	M	Issue No.	16
LM End	4.13	Issue Type +	Ma	Location *	LS
Category	Earthen Levee			GPS Latitude/Longitude	
				Start	End
Item	Vegetation			39.148967 °	39.142408 °
				-122.912208 °	-122.902510 °
DWR ID	DWR_MA0017_01_s_2016_16				
Comment Code					
V2 : Remove the wild growth other than native grasses from the levee slopes.					
Inspector Comment					
Large bushes and brambles growing on wire fence on LS toe limit visibility and access. Remove grasses and weeds.

5/2/2016: Remove or trim dense vegetation growing on fence to allow visibility and access to L/S toe.

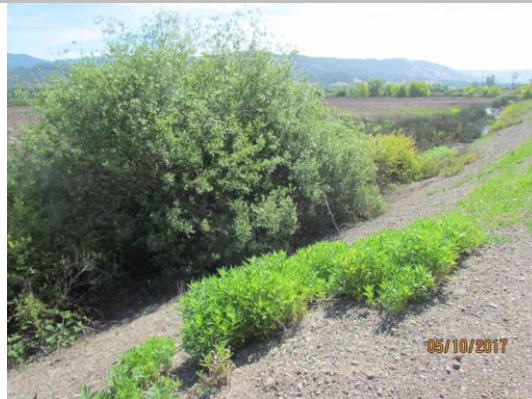
Photo 1 of 1 : SP\_2020\_MA0017\_339\_25\_20200302\_00007.jpg

LM Start	3.84	Rating **	M	Issue No.	25
LM End	3.84	Issue Type +	Ma	Location *	LS
Category	Earthen Levee			GPS Latitude/Longitude	
				Start	End
Item	Trim / Thin Trees			39.144695 °	39.144695 °
				-122.906668 °	-122.906668 °
DWR ID	DWR_MA0017_01_s _ 2017_25				
Comment Code					
T2 : Thin trees to allow visibility of the ground and room to flood fight.					
Inspector Comment					
Trim the trees along the landside toe.

View of the trees along the landside toe. Spring 2017

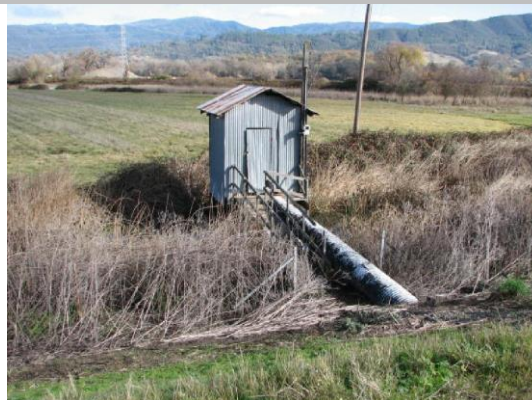
Photo 2 of 3 : UCIP\_SP\_2020\_55641\_46848.jpg

Pumphouse on piles at LS toe.

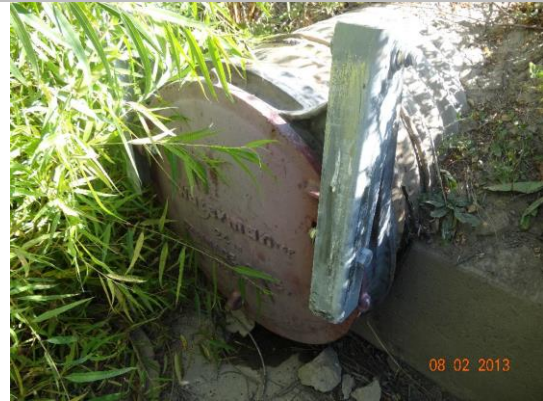
Photo 3 of 3 : UCIP\_SP\_2020\_55641\_46850.jpg

New flap gate on WS

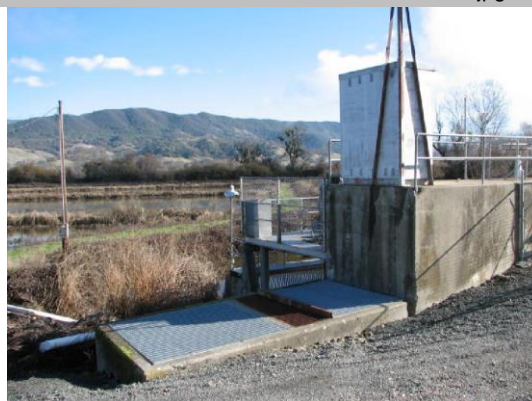
Photo 1 of 3 : UCIP\_SP\_2020\_55642\_46853.jpg

Comment Code					
Inspector Comment					
DS_ID:845 FS_ID:55642 EP_NO: 11464 Repair Type: Non-Urgent Crossing Status: Found UCIP Comments: 10/09/2019 The levee is maintained by DWR Sutter Yard. The State is currently working on purchasing adjacent land to eventually pursue the de-activation of this levee. Levee crown width through this section is about 12 feet. The UCIP inspection was completed with DWR Inspector, L. Dial, and DWR Sutter Yard Supervisor, B. Reniff. Crossing has been updated from No Action Needed to Non-Urgent; owner has changed [State maintains structure]. (O. Magana - DWR UCIP)10/27/2017 This structure is inspected annually under the Structure and Channel Summer Inspection (part of the Levee Inspection Program) conducted by the DWR Flood Project Integrity and Inspection Branch (FPIIB). (DWR UCIP - O. Magana) 10/19/2016 Crossing appears to be in good condition. (DWR Sutter Yard- A/Freitag)06/14/2016 crossing appears to be in good condition.04/23/2015 No issues with pipe.07/03/2014 Same as last inspection.12/23/2013 Same as last inspection.08/02/2013 Same as last inspection. FIELD_STRUCT_DESC: [Bloody Island Pumping Plant] 1 of 2: 42-inch corrugated metal drainage pipe through the levee, 20.2 feet below the crown. Concrete headwall and discharge apron on the waterside (WS) shoulder. Three vertical pump units mounted on a reinforced concrete pump platform in drainage ditch at the landside (LS) toe. Flap gates in concrete discharge well on the LS. Combination flap and slide gate on a gravity pipe from drainage ditch into discharge well. (two 42-inch pipes [HLM 4.18] authorized under Automatic Board Order (ABO) issued as Permit No. 11464, 1975 - Lake County). [Additional Reference(s): DWR Levee Log, 2005. USACE Sacramento O&M Manual 506.2, August 1961, (HLM 4.18)]. FS Date: 10/9/2019 2:59:00 PM

Pumping Plant on LS shoulder.

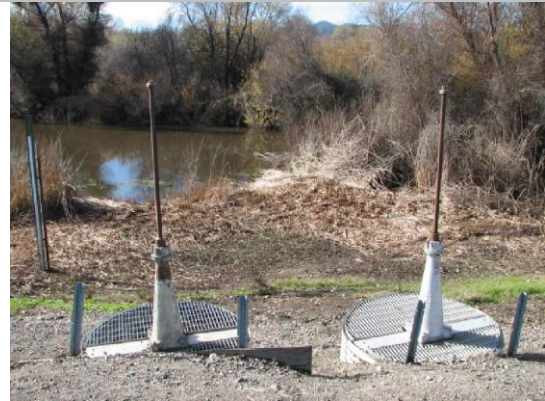
Photo 2 of 3 : UCIP\_SP\_2020\_55642\_46852.jpg

Slide gates in CMP risers on WS shoulder.

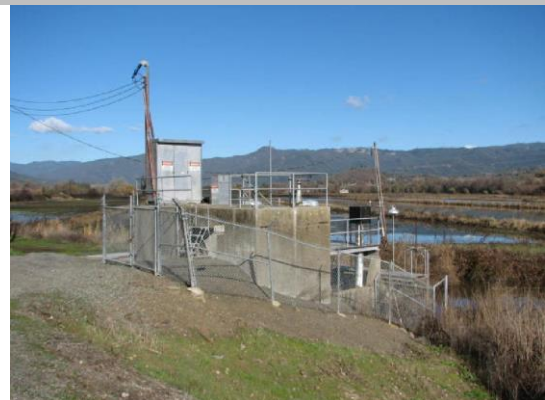
Photo 3 of 3 : UCIP\_SP\_2020\_55642\_46851.jpg

Pumping Plant on LS shoulder.

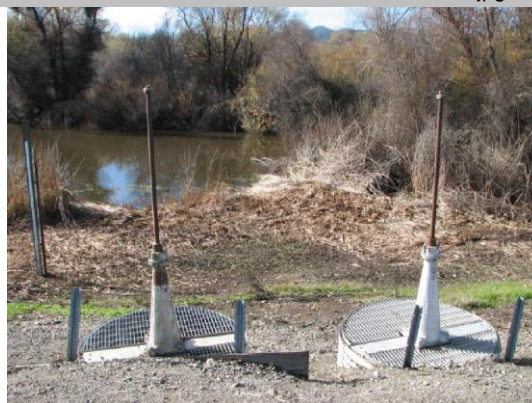
Photo 2 of 3 : UCIP\_SP\_2020\_56066\_46855.jpg

Slide gate in CMP riser on WS shoulder.

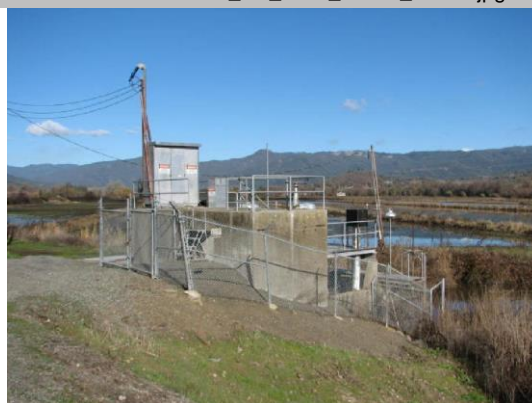
Photo 3 of 3 : UCIP\_SP\_2020\_56066\_46854.jpg

Pumping plant on LS shoulder.

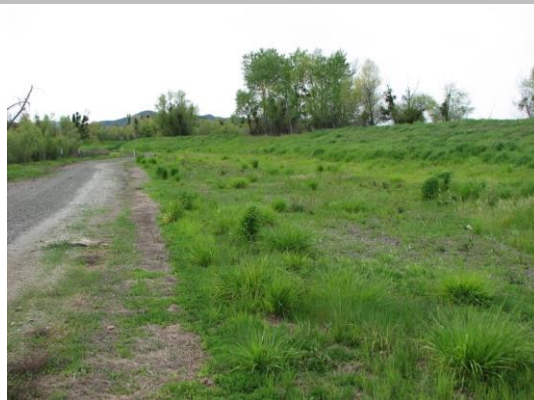
Photo 2 of 2 : SP\_2020\_MA0017\_339\_2\_20200302\_00002.jpg

Photo taken at LM 6.41 looking west showing overgrown LS slope of levee at right and toe road at left. Note trees obstructing visibility and access at levee crown. Crown is +/- 5 feet wide, and impassible to vehicles due to vegetation, and in some places, to pedestrians.  
4/19/2016

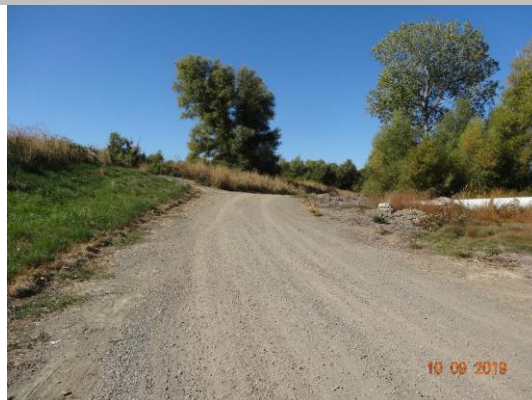
Photo 3 of 3 : UCIP\_SP\_2020\_55648\_82279.jpg

Overview of access road looking u/s towards pipe crossings.

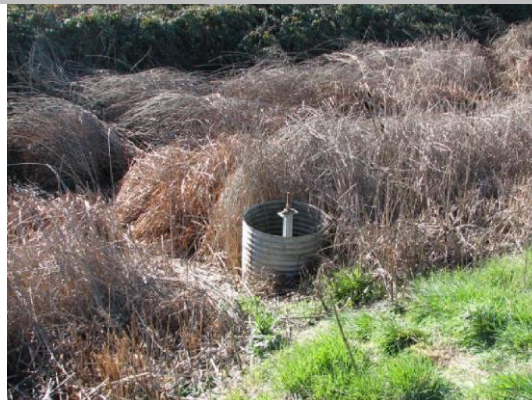
Photo 1 of 3 : UCIP\_SP\_2020\_55650\_46866.jpg

DS\_ID:848  
FS\_ID:55650  
EP\_NO: 11457  
Repair Type: Non-Urgent  
Crossing Status: Found  
UCIP Comments: 10/09/2019 The levee is maintained by DWR Sutter Yard. The State is currently working on purchasing adjacent land to eventually pursue the de-activation of this levee. Levee crown width ranges from 3 to 4-feet. The UCIP inspection was completed with DWR Inspector, L. Dial, and DWR Sutter Yard Supervisor, B. Reniff. Crossing remains Non-Urgent; crossing has been abandoned, no riser lid or slide gate wheel are present. DWR DMP geophysical investigation found signals of potential metal pipe through this section of the levee. Owner will need coordinate with the CVFPB to remove or abandon crossing according to Title 23 requirements. (O. Magana - DWR UCIP)

36-inch CMP riser and slide gate on WS slope.

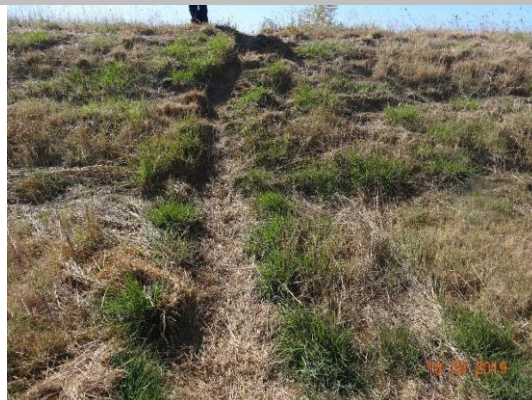
Photo 3 of 3 : UCIP\_SP\_2020\_55650\_82295.jpg

LS view: overview of LS slope.

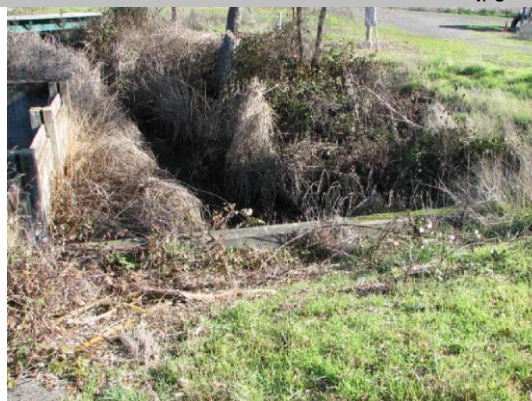
Photo 1 of 3 : UCIP\_SP\_2020\_55651\_46869.jpg

Comment Code						
Inspector Comment						
DS_ID:849 FS_ID:55651 EP_NO: 11467 Repair Type: Non-Urgent Crossing Status: Found UCIP Comments: 10/09/2019 The levee is maintained by DWR Sutter Yard. The State is currently working on purchasing adjacent land to eventually pursue the de-activation of this levee. Levee crown width is about 12 feet. The UCIP inspection was completed with DWR Inspector, L. Dial, and DWR Sutter Yard Supervisor, B. Reniff. Crossing has been updated from No Action Needed to Non-Urgent; need to audit record to confirm if ABO lists current owner for this structure. (O. Magana - DWR UCIP)10/27/2017 This structure is inspected annually under the Structure and Channel Summer Inspection (part of the Levee Inspection Program) conducted by the DWR Flood Project Integrity and Inspection Branch (FPIIB). (DWR UCIP - O. Magana) 10/19/2016 Crossing appears to be in good condition. (DWR Sutter Yard- AFreitag)06/14/2016 Flap gate propped open. Will make sure its closed before flood season.04/23/2015 Flap gate propped open. Not an issue at this time. Will close it before high water season.07/03/2014 Same as last inspection12/23/2013 Same as last inspection.08/02/2013 Same as last inspection. FIELD_STRUCT_DESC: [Highland Canal Diversion Weir and Drainage] 1 of 2: 54-inch corrugated metal drainage pipe through the levee 11.5 feet below the crown. Highland Canal Diversion Weir and Drainage Structure on the landside (LS). Concrete headwall on both landside (LS) and waterside (WS) toe with flap gate on the WS toe. (two 54-inch pipes [HLM 6.05] authorized under Automatic Board Order (ABO) issued as Permit No. 11467, 1975 - Modglin). [Additional Reference(s): DWR Levee Log, 2005, HLM 6.05. USACE Sacramento O&M Manual 506.3, August 1961, (HLM 6.05), two 54-inch pipes]. FS Date: 10/9/2019 3:05:00 PM

Concrete weir/dam and channel on LS toe.

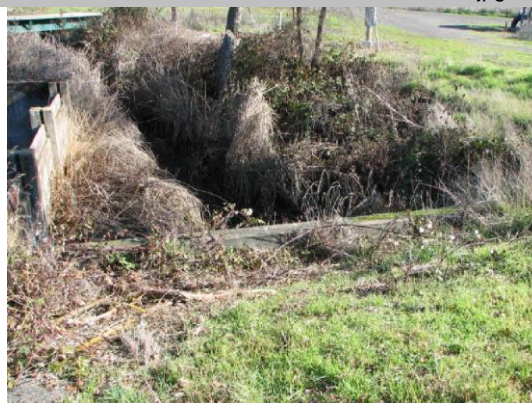
Photo 1 of 3 : UCIP\_SP\_2020\_55773\_46872.jpg

DS\_ID:854  
FS\_ID:55773  
EP\_NO: 11467  
Repair Type: Non-Urgent  
Crossing Status: Found  
UCIP Comments: 10/09/2019 The levee is maintained by DWR Sutter Yard. The State is currently working on purchasing adjacent land to eventually pursue the de-activation of this levee. Levee crown width is about 12 feet. The UCIP inspection was completed with DWR Inspector, L. Dial, and DWR Sutter Yard Supervisor, B. Reniff. Crossing has been updated from No Action Needed to Non-Urgent; need to audit record to confirm if ABO lists current owner for this structure. (O. Magana - DWR UCIP)10/27/2017 This structure is inspected annually under the Structure and Channel Summer Inspection (part of the Levee Inspection Program) conducted by the DWR Flood Project Integrity and Inspection Branch (FPIIB). (DWR UCIP - O. Magana)  
10/19/2016 Crossing appears to be in good condition. (DWR Sutter Yard- A/Freitag)06/14/2016 Flap gate propped open. Will make sure its closed before flood season.04/23/2015 Flap gate propped open. Not an issue at this time. Will close it before high water season.07/03/2014 Same as last inspection.12/23/2013 Same as last inspection.08/02/2013 Same as last inspection.

Concrete dam/weir and channel on LS toe.

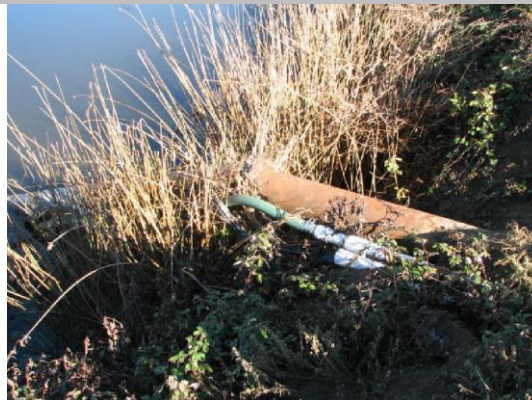
Photo 1 of 3 : UCIP\_SP\_2020\_56065\_46882.jpg

Comment Code					
Inspector Comment					
DS_ID:850 FS_ID:56065 EP_NO: 11467 Repair Type: Urgent Crossing Status: Found UCIP Comments: 10/09/2019 The levee is maintained by DWR Sutter Yard. The State is currently working on purchasing adjacent land to eventually pursue the de-activation of this levee. Levee crown width is more than 12 feet. The UCIP inspection was completed with DWR Inspector, L. Dial, and DWR Sutter Yard Supervisor, B. Reniff. Crossing remains Urgent; WS erosion is still present along WS slope. This crossing has been modified. It appears that this pipe is conveying water from WS to LS and LS to WS. Recommend auditing record to determine current owner. (O. Magana - DWR UCIP)09/06/2018 Same as last inspection; WS erosion is still present so the crossing remains Urgent (D. Sanoski - DWR UCIP).10/19/2016 WS erosion still present. (DWR Sutter Yard- AFreitag)06/14/2016 WS erosion is still present. (DWR Sutter Yard - afreitag)04/23/2015 Same as last inspection. (DWR Sutter Yard - afreitag)07/03/2014 Same as last inspection. (DWR Sutter Yard - afreitag)12/23/2013 Same as last inspection. (DWR Sutter Yard - afreitag)08/02/2013 Same as last inspection. (DWR Sutter Yard - afreitag)12/13/2012 The pipe and appurtenances do not match what was described in the permit (PN: 11467). Does not appear to be in compliance with board regulations. (DWR UCIP - wwylie) FIELD_STRUCT_DESC: 12-inch steel drainage pipe through the levee, 2 feet below the crown. Butterfly valve on the landside (LS) shoulder. Pump and electrical panel, along with multiple valves and appurtenances, on the LS shoulder. (12-inch pipe [HLM 6.11] authorized under Automatic Board Order (ABO) issued as Permit No. 11467, 1975 - B. F. Modglin). [Additional Reference(s): DWR Levee Log, 2005. USACE Sacramento O&M Manual 506.3, 1967, (HLM 6.11)]. FS Date: 10/9/2019 2:56:00 PM

12-inch pipe and appurtenances on WS shoulder.

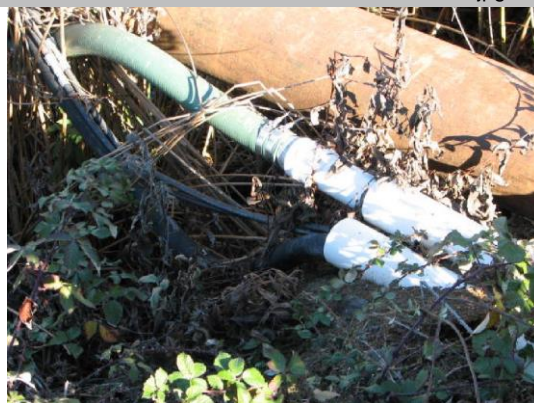
Photo 2 of 3 : UCIP\_SP\_2020\_56065\_46881.jpg

12-inch pipe and appurtenances on WS shoulder.

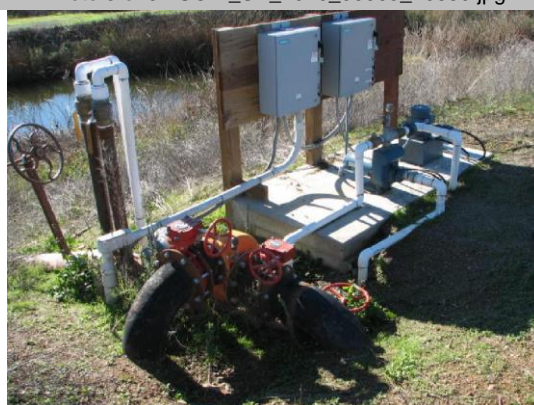
Photo 3 of 3 : UCIP\_SP\_2020\_56065\_46880.jpg

Pumping plant and appurtenances on LS shoulder.

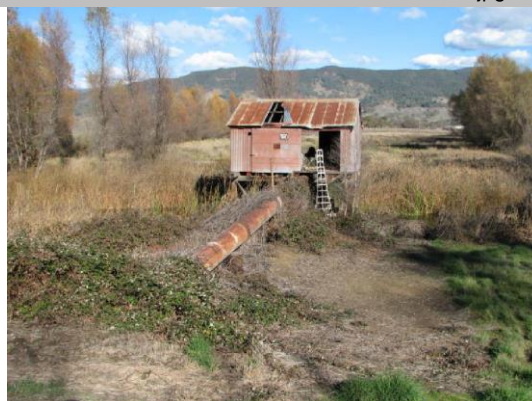
Photo 1 of 3 : UCIP\_SP\_2020\_55658\_46884.jpg

Comment Code						
Inspector Comment						
DS_ID:851 FS_ID:55658 EP_NO: 11467 Repair Type: Non-Urgent Crossing Status: Found UCIP Comments: 10/09/2019 The levee is maintained by DWR Sutter Yard. The State is currently working on purchasing adjacent land to eventually pursue the de-activation of this levee. Levee crown width is about 12 feet. The UCIP inspection was completed with DWR Inspector, L. Dial, and DWR Sutter Yard Supervisor, B. Reniff. Crossing remains Non-Urgent; crossing has been abandoned. Owner will need coordinate with the CVFPB to remove or abandon crossing according to Title 23 requirements. (O. Magana - DWR UCIP)10/19/2016 Abandoned- should be done so properly. (DWR Sutter Yard-AFreitag)06/14/2016 Abandoned crossing.04/23/2015 Same as last inspection. Pipe still needs to be properly abandoned.07/03/2014 Same as last inspection.12/23/2013 Same as last inspection.08/02/2013 Same as last inspection.12/13/2012 Pipe should be properly abandoned. FIELD_STRUCT_DESC: *ABANDONED* 1 of 2: 16-inch steel drainage pipe through the levee, 8 feet below the crown. Drainage pumping plant on the landside (LS). Flap gate on the waterside (WS) end. Steel plate welded on end of pipe at LS toe. (one 16-inch and one 24-inch pipes [HLM 7.79] authorized under Automatic Board Order (ABO) issued as Permit No. 11467, 1975 - Modglin). [Additional Reference(s): DWR Levee Log, 2005. USACE Sacramento O&M Manual 506.3, August 1961, (HLM 7.19)]. FS Date: 10/9/2019 3:11:00 PM

Pumping plant in shed on LS at drainage ditch.

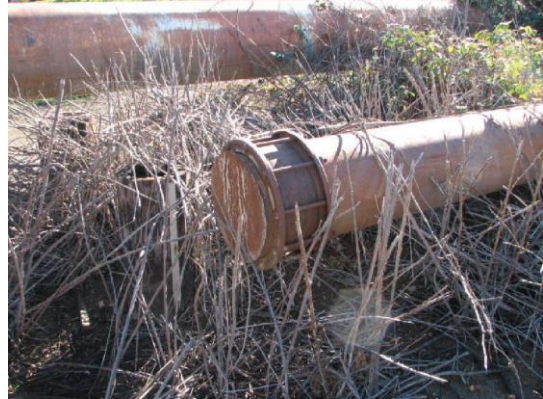
Photo 2 of 3 : UCIP\_SP\_2020\_55658\_46883.jpg

Steel plate welded over end of pipe at LS toe.

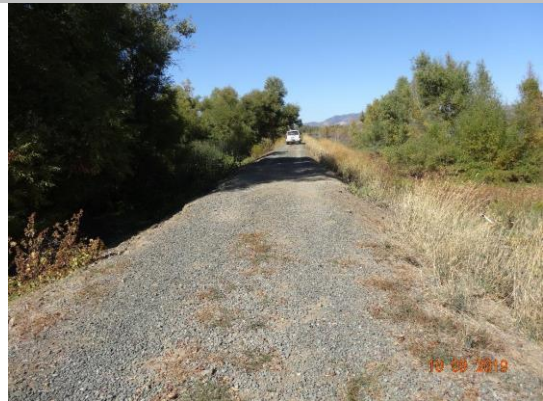
Photo 3 of 3 : UCIP\_SP\_2020\_55658\_82325.jpg

Overview of levee crown looking u/s towards pipe crossing.

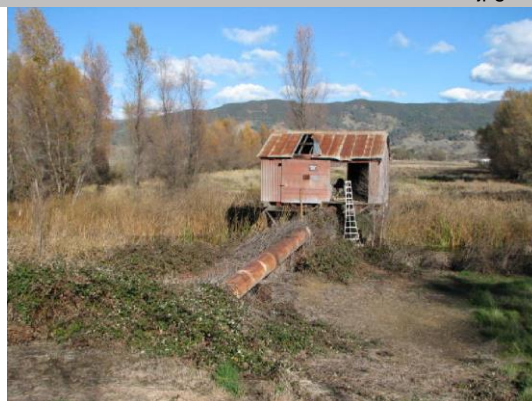
Photo 1 of 3 : UCIP\_SP\_2020\_55660\_46886.jpg

Comment Code						
Inspector Comment						
DS_ID:855 FS_ID:55660 EP_NO: 11467 Repair Type: Non-Urgent Crossing Status: Found UCIP Comments: 10/09/2019 The levee is maintained by DWR Sutter Yard. The State is currently working on purchasing adjacent land to eventually pursue the de-activation of this levee. Levee crown width is about 12 feet. The UCIP inspection was completed with DWR Inspector, L. Dial, and DWR Sutter Yard Supervisor, B. Reniff. Crossing remains Non-Urgent; crossing has been abandoned. Owner will need coordinate with the CVFPB to remove or abandon crossing according to Title 23 requirements. (O. Magana - DWR UCIP)10/19/2016 Crossing appears to be in good condition. (DWR Sutter Yard-AFreitag)06/14/2016 Crossing appears to be in good condition.04/23/2015 No issues seen with pipe.07/03/2014 Same as last inspection.08/02/2013 Same as last inspection.12/23/2013 Same as last inspection. FIELD_STRUCT_DESC: 2 of 2: 24-inch steel drainage pipe through the levee, 8 feet below the crown. Drainage pumping plant on the landside (LS). Flap gate on the waterside (WS) end. (one 16-inch and one 24-inch pipes [HLM 7.79] authorized under Automatic Board Order (ABO) issued as Permit No. 11467, 1975 - Modglin). [Additional Reference(s): DWR Levee Log, 2005. USACE Sacramento O&M Manual 506.3, August 1961, (HLM 7.19)]. FS Date: 10/9/2019 3:12:00 PM

24-inch steel pipe and pump house on LS.

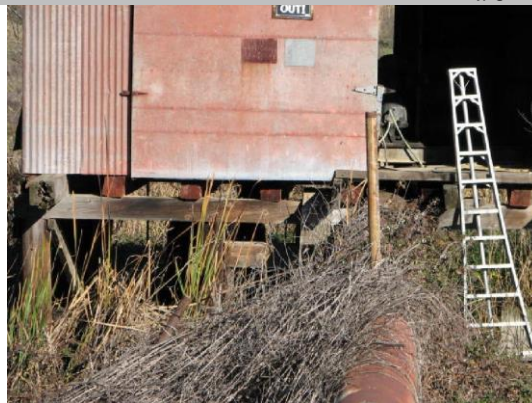
Photo 2 of 3 : UCIP\_SP\_2020\_55660\_46885.jpg

Air vent on pipe at LS pumphouse.
